MODIFIED HABS/HAER REPORT
**SPRECKELS SUGAR COMPANY
FACTORY No. 1**
SPRECKELS, CALIFORNIA

VOLUME 2: PHOTOGRAPHS

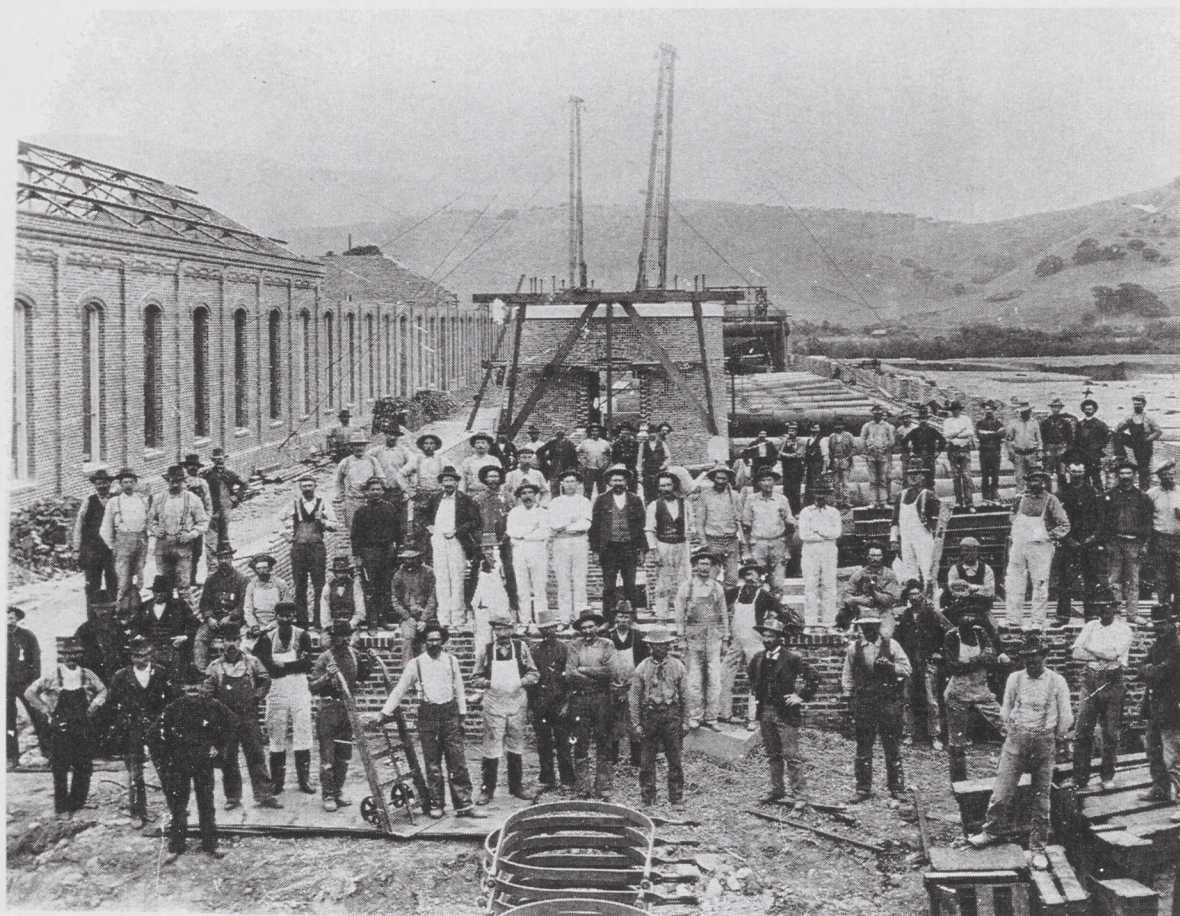
8. Boiler House (No. 2) under construction.
Photo c. 1897.

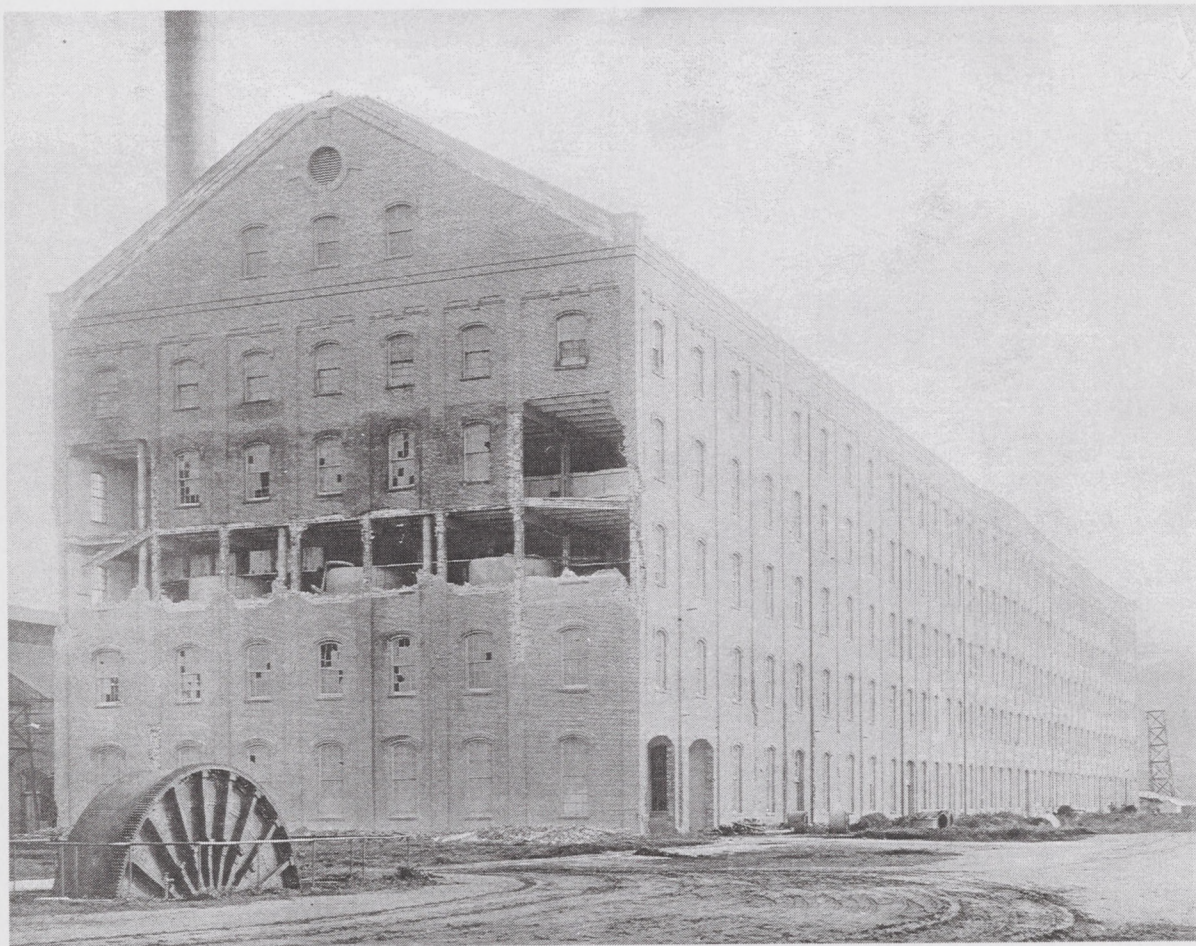
34. Earthquake damage to north and west facades of the Main Building (No. 1).
Photo 1906.

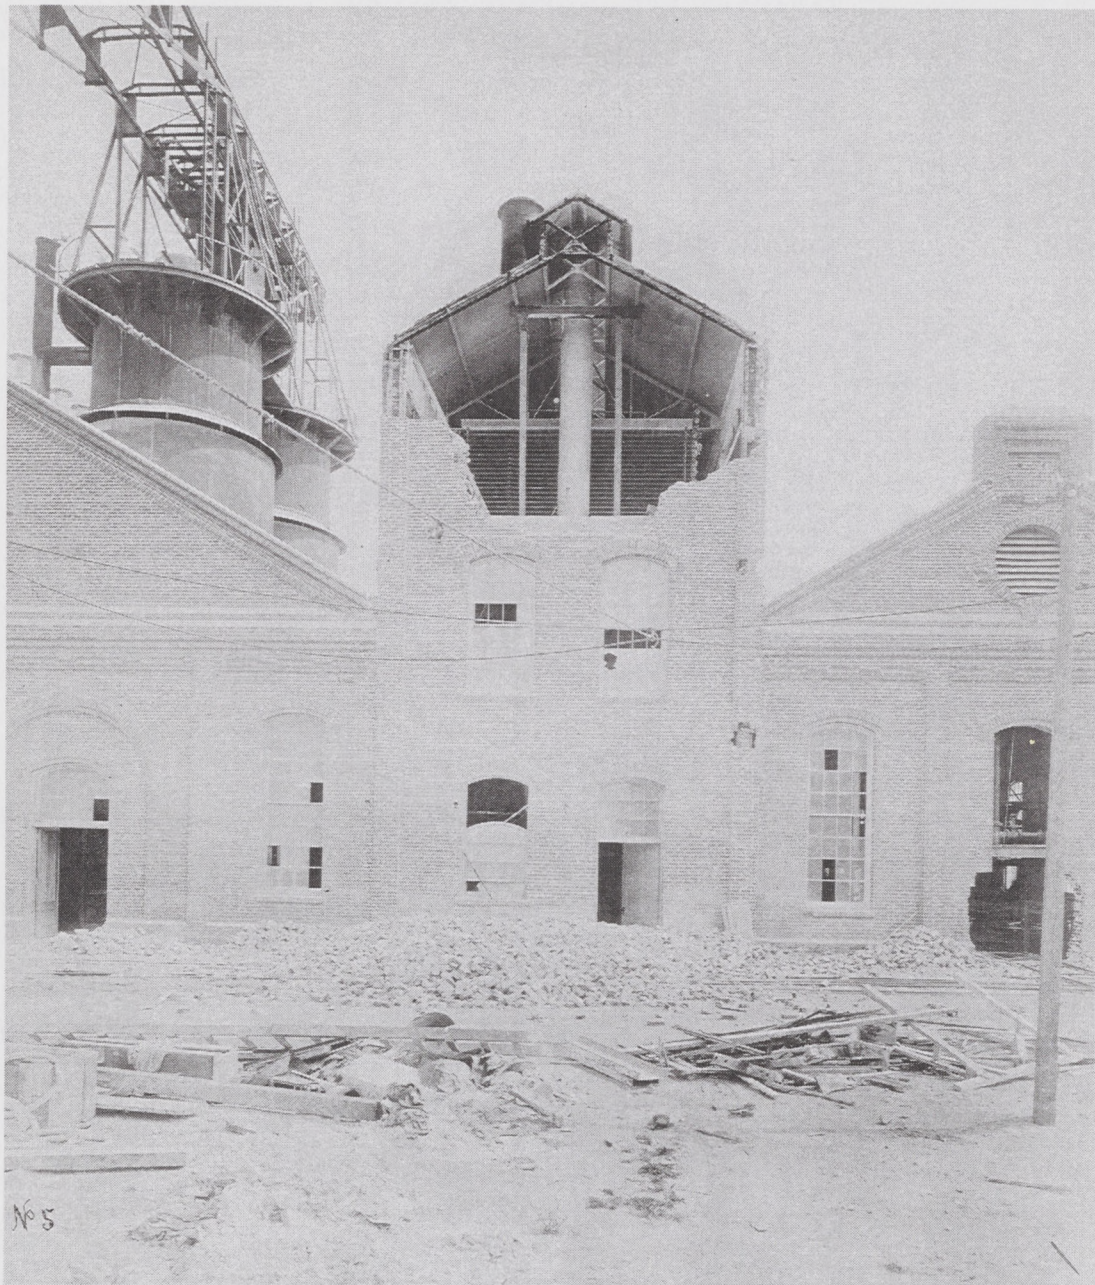
40. Left to right: Lime Kiln Room at end of Boiler House, Extraction Plant, and Steffen Filter Press Room.

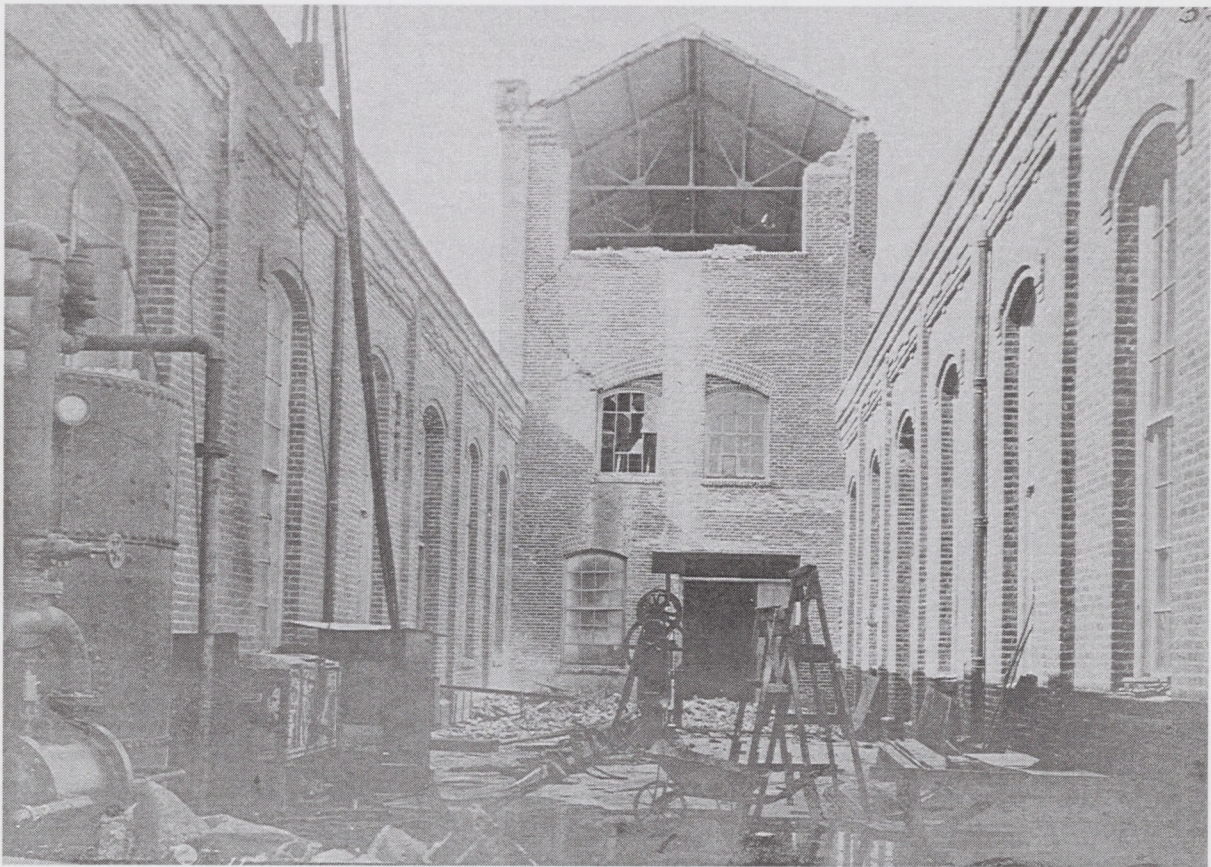
41. Extraction Plant.

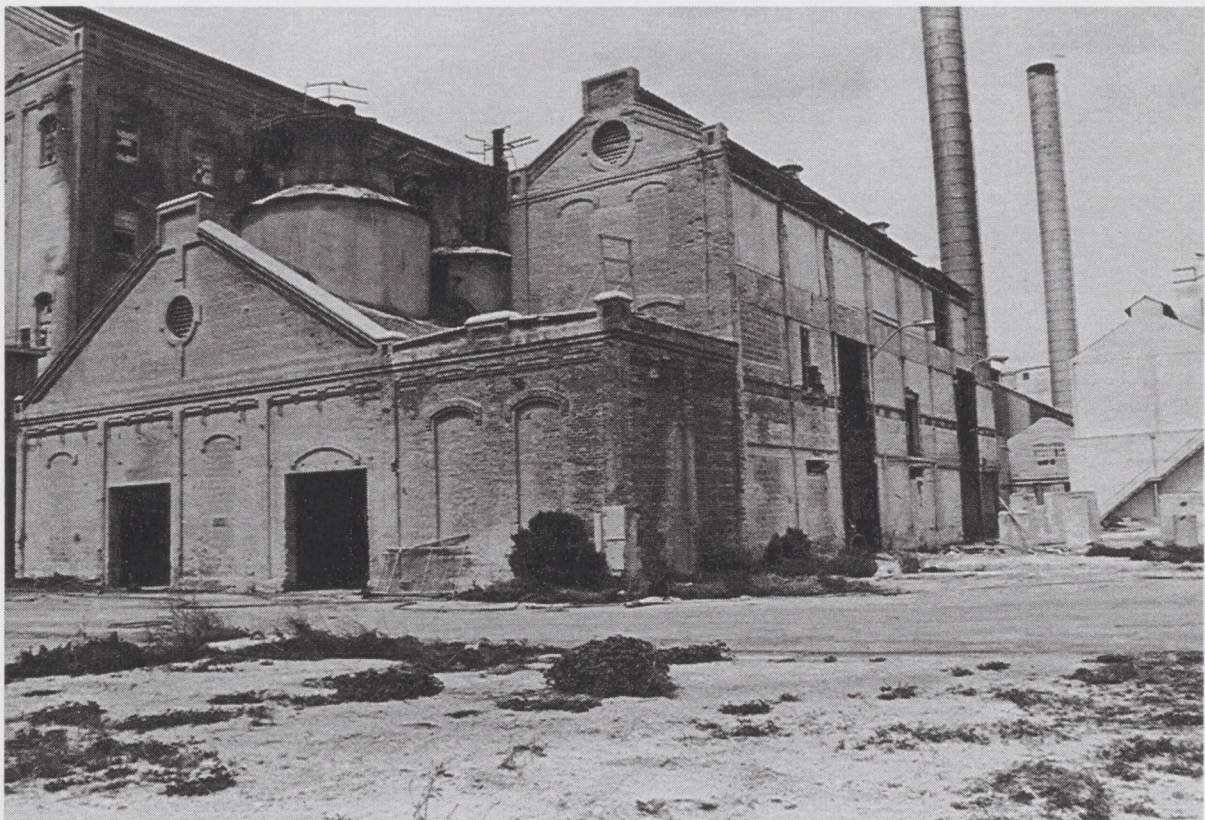
42. Boiler House and Extraction Plant.

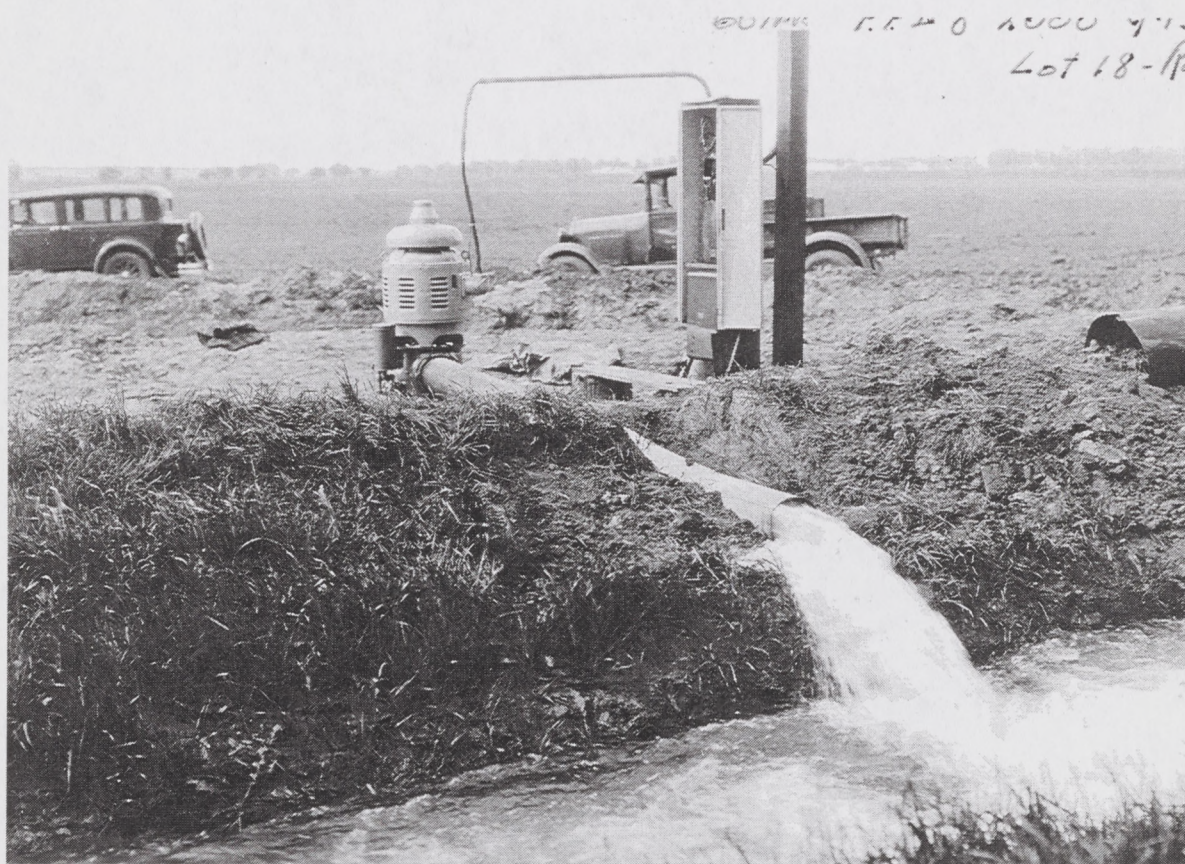
98. Electric pump at Ranch No. 3.
Photo c. 1930.
Electric pumps began to replace steam-powered pumps by 1920.

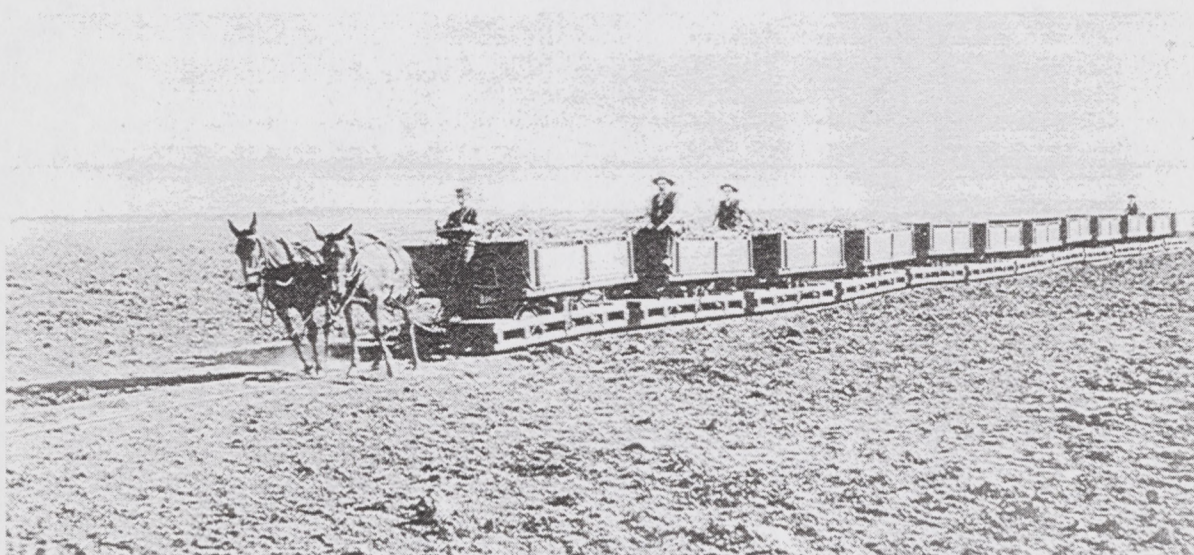
99. Temporary tracks into beet fields, Moro Cojo Ranch.
Photo c. 1895.

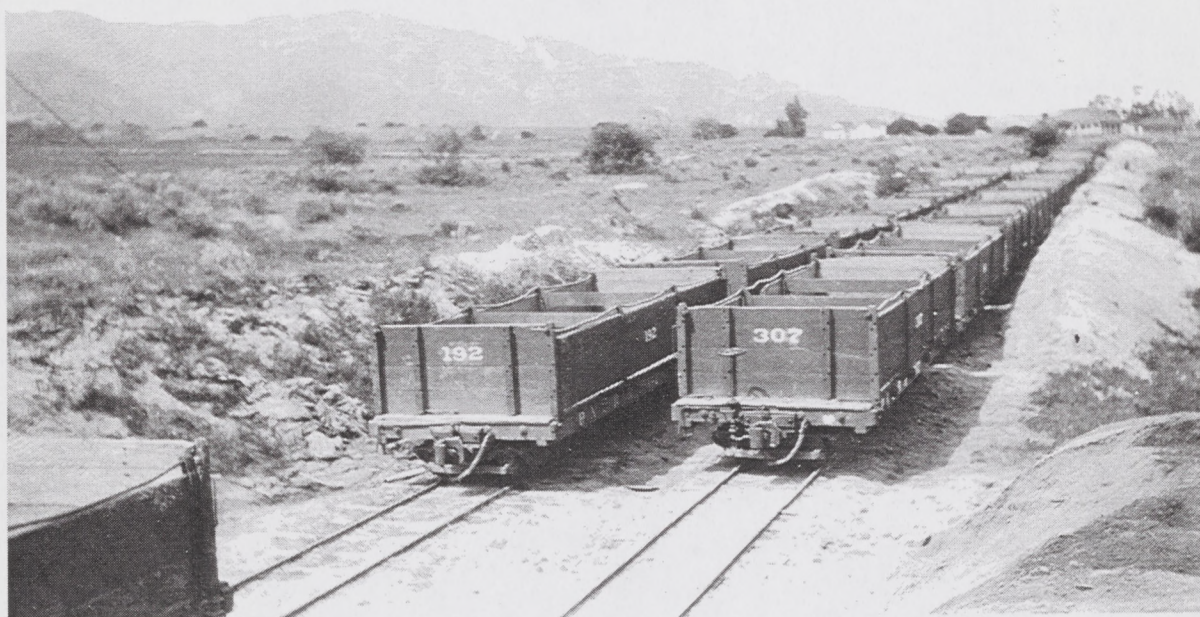
101. PVCRR gondola cars.
Photo c. 1910.
Typical freight cars on the PVCRR.
